# **Test Report No. AFS-R1071**

The Neuffer Eco Plano Wood/Alu fixed light window unit comprised of a nominal 2000mm high x 1250mm wide outer box frame which incorporated a clear triple glazed IGU, retained by internal glazing beads.

The Neuffer Eco Plano Wood/Alu fixed light window unit was tested in accordance with NZS 4211:2008, Specification for Performance of Windows, with test procedures as detailed in sections of AS/NZS 4420.1:2016.

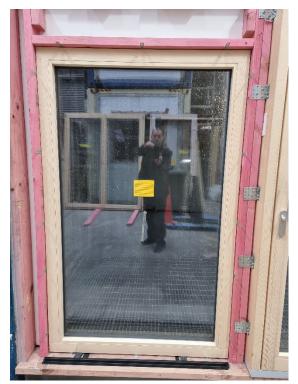
Photo 1: Interior of the Neuffer fixed light window installed in the test booth.

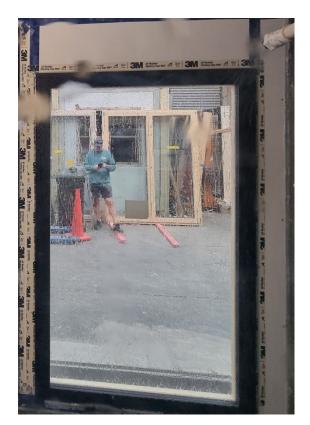
Photo 2: Exterior of the Neuffer fixed light window installed in the test booth.
