Test Report No. AFS-R1076

Sample Designer: Neuffer Fenster + Tueren GMBH

Performance testing of the Neuffer Eco Plano Wood/Alu Balcony Door unit in accordance with the NZS 4211:2008 Specification for Performance of

Windows.

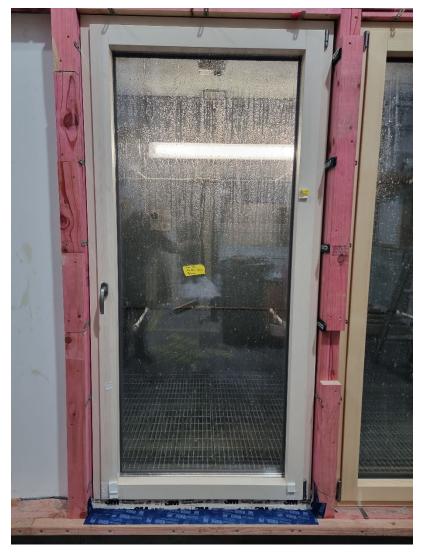
Photo 1: Interior of the Neuffer Eco Plano Wood/Alu Balcony door installed in the test booth.

The Neuffer Eco Plano Wood/Alu open in Balcony door unit with overall (box size) dimensions of 2298mm high x 1100mm wide, was installed by Glazing 360 Limited into the timber framed opening of the test booth with the window exterior facing the inside of the booth.

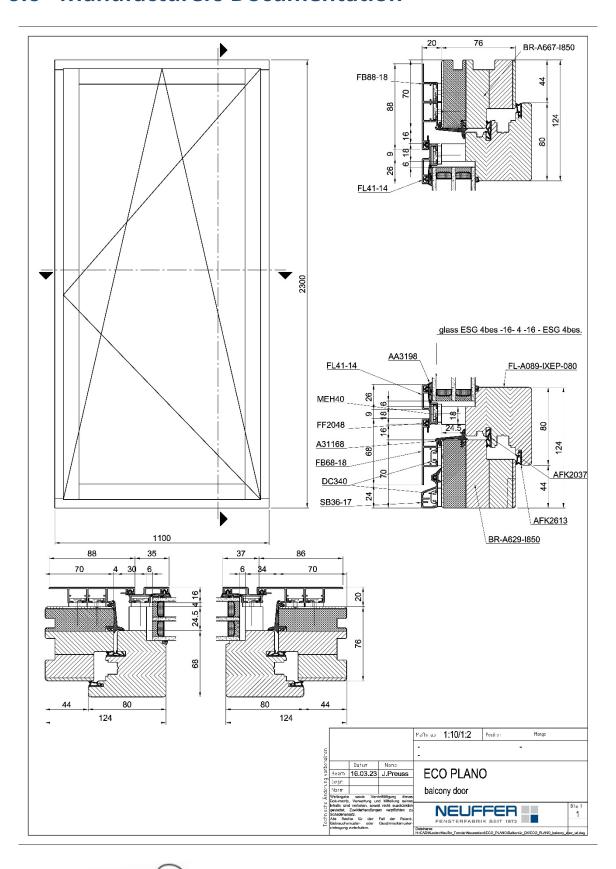
Bill of materials							
Product: ECO PLANO balcony door, tilt and turn								
no.	description	quantity	item number	material	supplier			
1	frame	3	BR-A667-I850	pinewood	IDEAL			
2	frame	1	BR-A629-I850	pinewood	IDEAL			
3	sash	4	FL-A089-IxEP-080	pinewood	IDEAL			
4	glass ESG 4bes-16Ar-4-16-4bes. 0,6Ug	1	WS 0,6/48	glass	Glaskontor			
5	window handle Atlanta secustic	1	615-F9016	aluminium	Норре			
6	gasket	4	FF2048	EPDM	Stemeseder			
7	gasket	8	AFK2613	EPDM	Stemeseder			
8	gasket	7	MFK2037	EPDM	Stemeseder			
9	gasket	1	A31168	EPDM	Stemeseder			
10	gasket	1	AA3198	EPDM	Stemeseder			
11	cladding profile	3	FB88-18	aluminium	Stemeseder			
12	cladding profile	4	FL41-14	aluminium	Stemeseder			
13	cladding profile	1	SB36-17	aluminium	Stemeseder			
14	cladding profile	1	FB68-18	aluminium	Stemeseder			
15	clip	8	DC340	plastic	Stemeseder			
16	clip	78	MEH40	plastic	Stemeseder			
17	wooden strip	4	FL 18x24,5	pinewood	IDEAL

18	handle shell	1	MG01	aluminium	Stemeseder			
19	screw 2.3x17mm	2	MEH40	steel	Würth

Details of the Neuffer Eco Plano Wood/Alu Balcony Door unit are shown on the attached Neuffer Fenster drawings numbered 1 - 19.
