Test Report No. AFS-R1072

Sample Designer: Neuffer Fenster + Tueren GMBH

Performance testing of the Neuffer Idealu 68 Wood/Alu fixed light window unit in accordance with the NZS 4211:2008 Specification for Performance of

Windows.

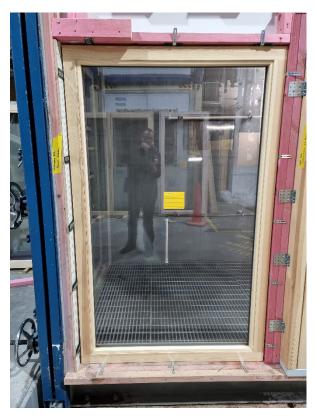
Photo 1: Interior of the Neuffer fixed light window installed in the test booth.

The Neuffer Idealu 68 Wood/Alu fixed light window unit with overall (box size) dimensions of 1996mm high x 1243mm wide, was installed by Enveloped Solutions Limited and Glazing 360 Limited into the timber framed opening of the test booth with the window exterior facing the inside of the booth.

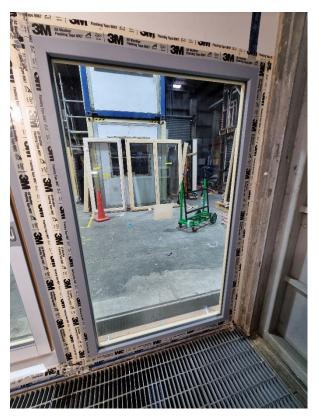
Photo 2: Exterior of the Neuffer fixed light window installed in the test booth.

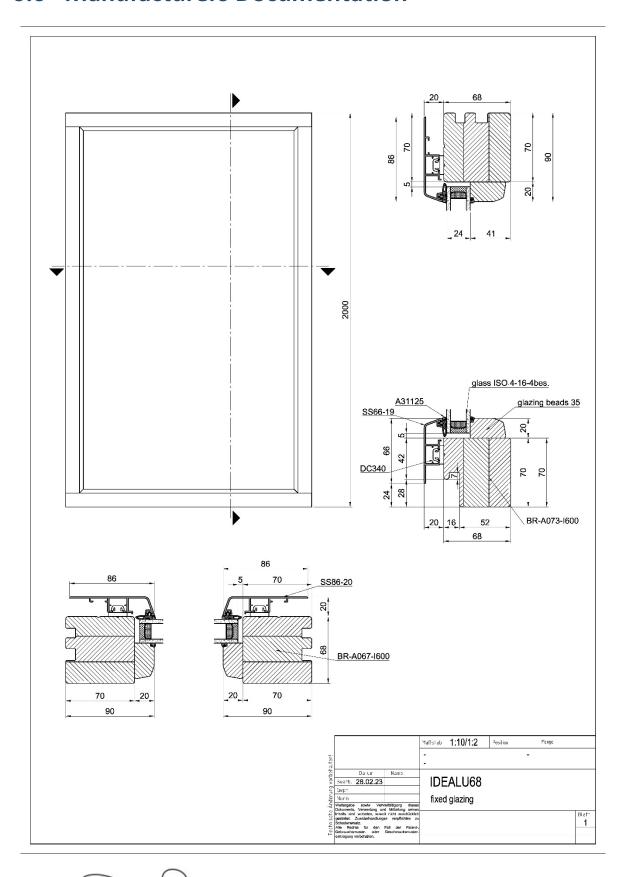
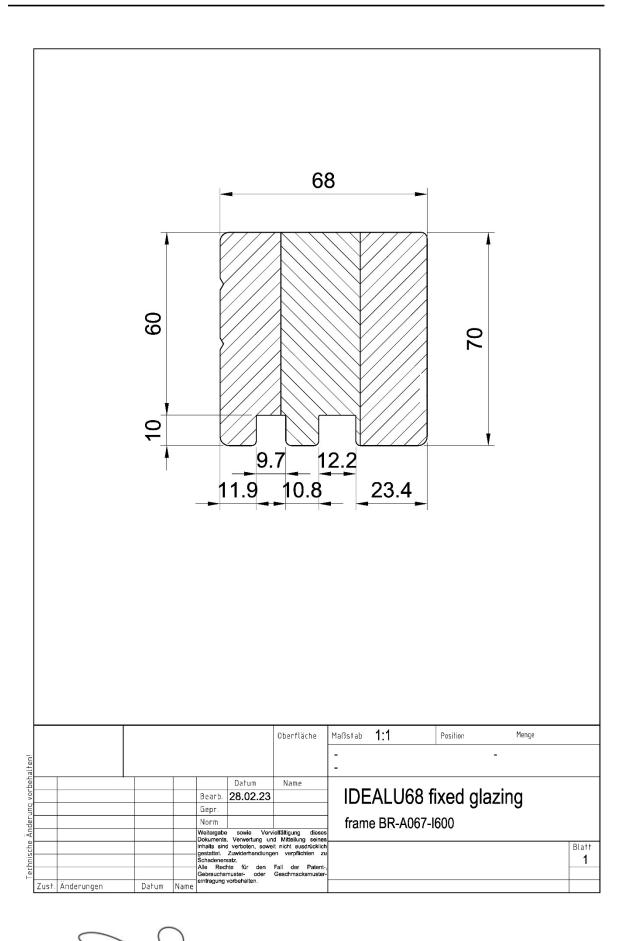
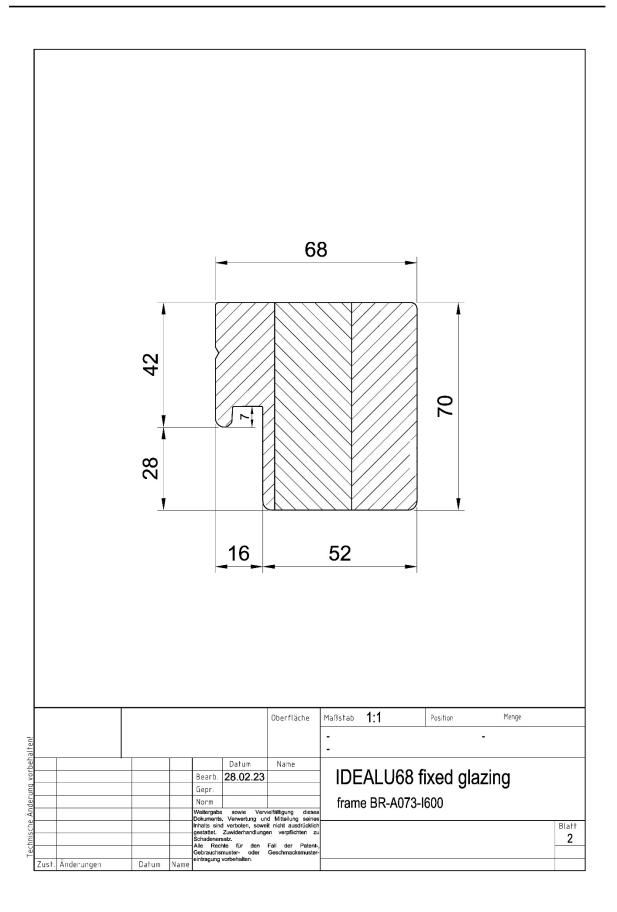
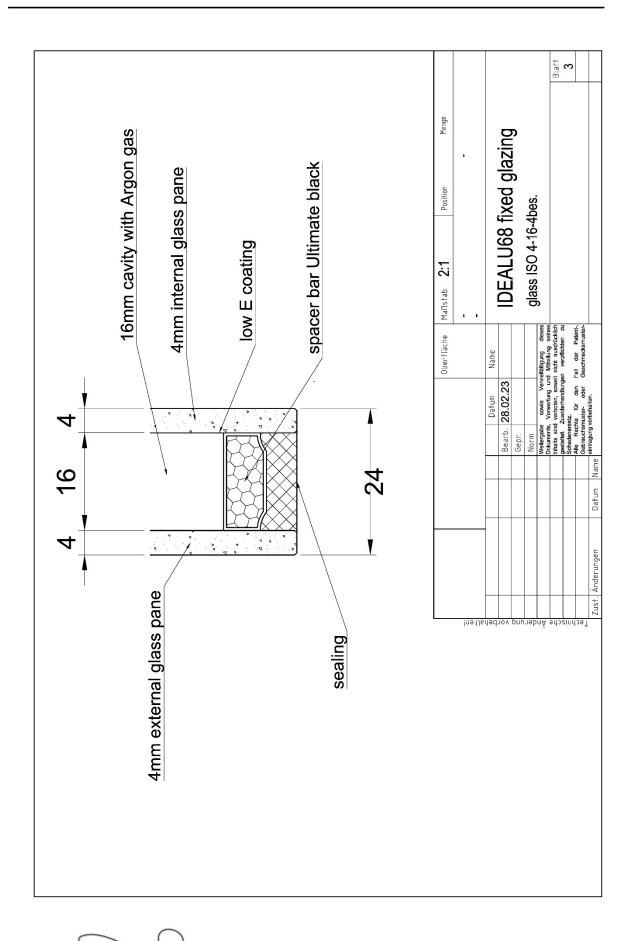
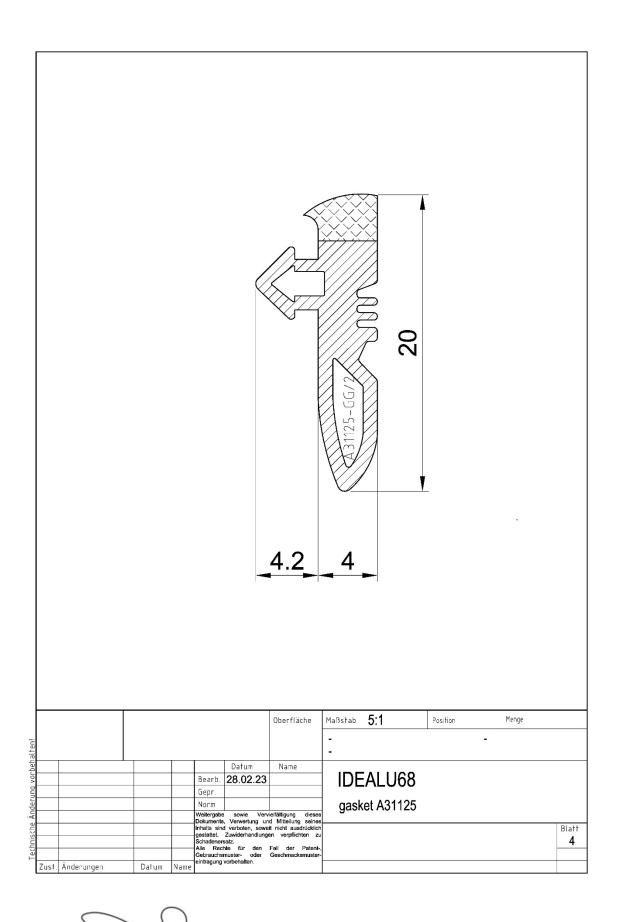
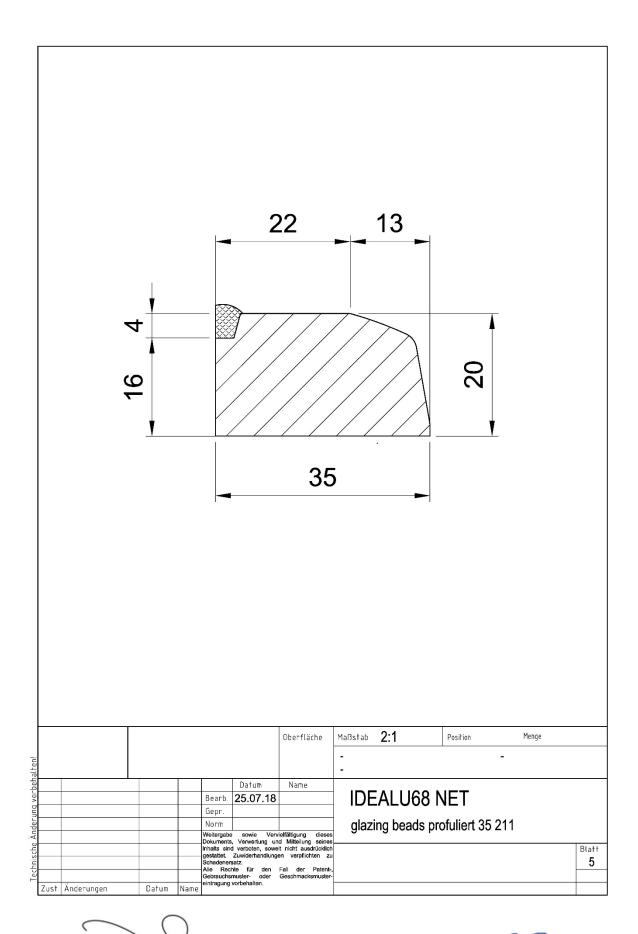
6.0 Manufacturers Documentation

Details of the Neuffer Idealu 68 Wood/Alu fixed light window unit are shown on the attached Neuffer Fenster drawings numbered 1 - 8.

The drawings identified the following timber profiles, aluminium extrusions and components being used in the construction of the Neuffer Idealu 68 Wood/Alu fixed light window unit.

BR-A067-I600 Timber outer frame – head and jambs

BR-A073-I600 Timber outer frame – sill

SS86-20 Aluminium cladding profile (88mm) SS66-19 Aluminium cladding profile (68mm)

A31125 EPDM glazing gasket

DC340 Plastic clip

20 x 35mm glazing bead Timber glazing bead Sealant Durasil W15 Plus
